# **A Report on Arsenicosis in District Ballia, Uttar Pradesh**

**(Feb. 08-10, 2011)**

# WSSO

**Water & Sanitation Support Organization, U.P.**

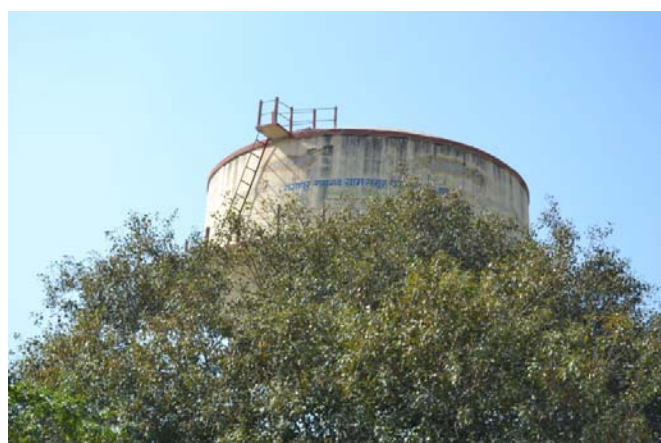
**Over head tank for Ganga Pur Pipe Water Scheme**

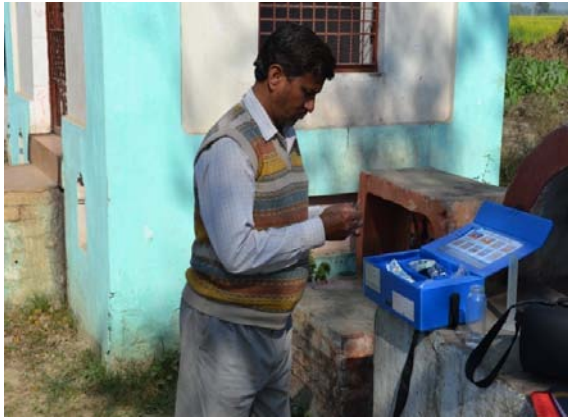
1. Arsenic is found in those Hand pumps, which draw water from the aquifer encountered at 50- 75 feet below ground level (bgl). This has been confirmed by Arsenic testing kit in Turha tola of Chain Chhapra village where 110 ppb of Arsenic was found. Cases of Melanosis were also observed.

**Arsenic testing of water sample by FTK**

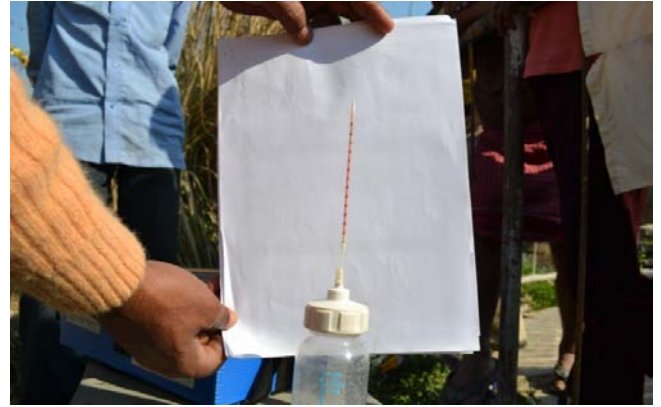
**Red colour shows the presence of Arsenic in water sample.**

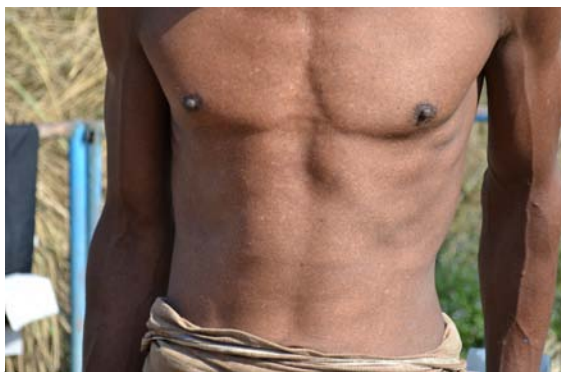
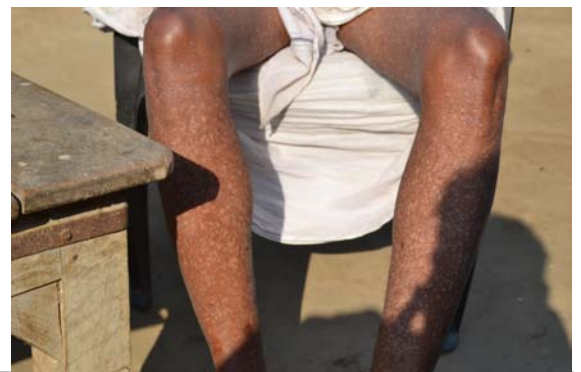
2. During the course of investigation in Turha tola of Chain Chhapra village, cases of Melanosis were observed with manifestation of white spot on legs and abdominal region in a numbers of persons belonging to different age groups.

**White spot ( Melanosis) found on body due to consumption of Arsenic contaminated**

- A mass awareness programme and capacity building campaign must be launched in Dist. Ballia at the earliest. Inter personal communication and other media of communication must be used to spread the importance of using Arsenic removal units (ARU), safety of water supply schemes and their management.
- Water security plan at village level must be prepared.
- Strengthening of District laboratory required.
- Capacity building of the Chemist to test other parameters e.g. Fluoride, Nitrate and Iron by using Spectrophotometer is also required.
- Appropriate status of schemes to be updated on the IMIS ver: 2 on [www.ddws.nic.in](http://www.ddws.nic.in) web site.

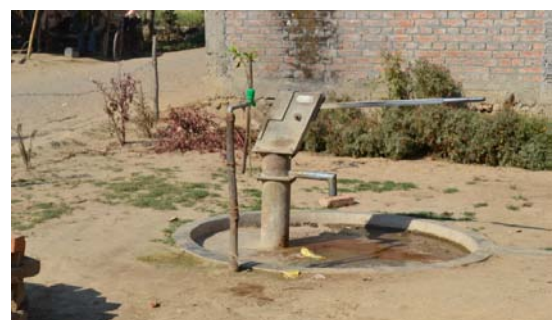
3. Jal Nigam provides safe potable water in Arsenic affected habitations through Hand pumps installed on deep bore wells, tapping potable water aquifer, or attachment for treatment of Arsenic and Pipe water

**Deep bore Hand pump & tap connection in Arsenic affected village of Gangapur, District: Ballia**

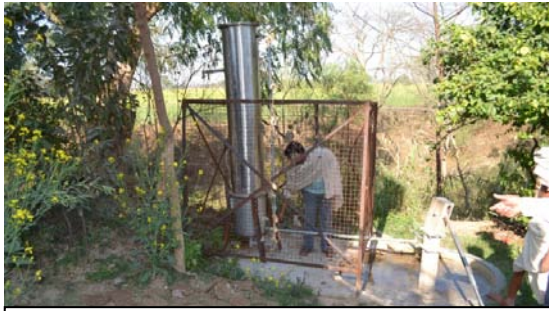
**Installation of Arsenic Removal Units by Jal Nigam to provide Arsenic free water**

6. Due to lack of awareness, villagers are reluctant to use the Hand pump Arsenic removal attachment.
  7. Discussions were held with people of Chain Chhapra, Noor pur and Gangapur villages, regarding formation of Pani Samati for management of water supply schemes, to which they have agreed.

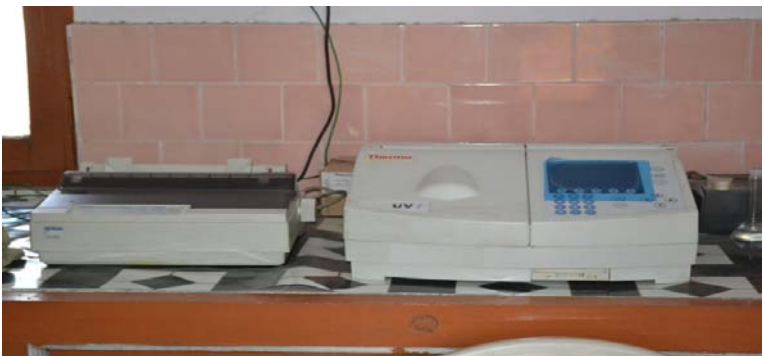
8. It was also observed that at a few places, connections are loose due to high pressure in pipe line.
  9. District Laboratory of U.P. Jal Nigam was also visited. They have Spectro photometer for Arsenic testing and Chemist uses it for confirmatory tests.
